# Manhole Inspection Summary

Manhole # S55C\_\_012MH

**Inspection** ☐ Is Incomplete Rating: **4) Poor**

**Location** Address: **3800 e baltimore st**

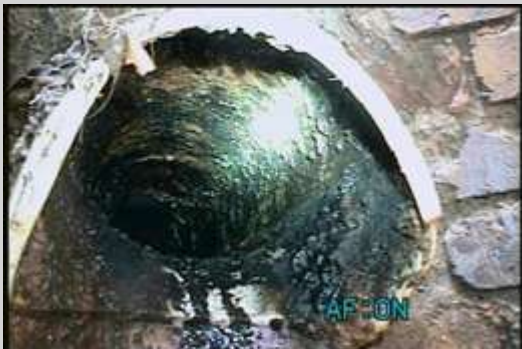
1 O'Clock Inflow

Pipe Height: 0 (in.) Direct

Pipe Material: PVC ☐ Pipe Lined

Infiltration: None Pipe Seal Cond: Unknown
